**EVALUATION OF THE MICROBIOLOGICAL
QUALITY OF WATER FOR CONSUMPTION
AT THE OCEAN SKY GARMENT
MANUFACTURING FACILITIES**

**Presented by: Laboratory for Agricultural Chemistry
Services, UCA**

For: FAIR LABOR ASSOCIATION

Date: March 15, 2011

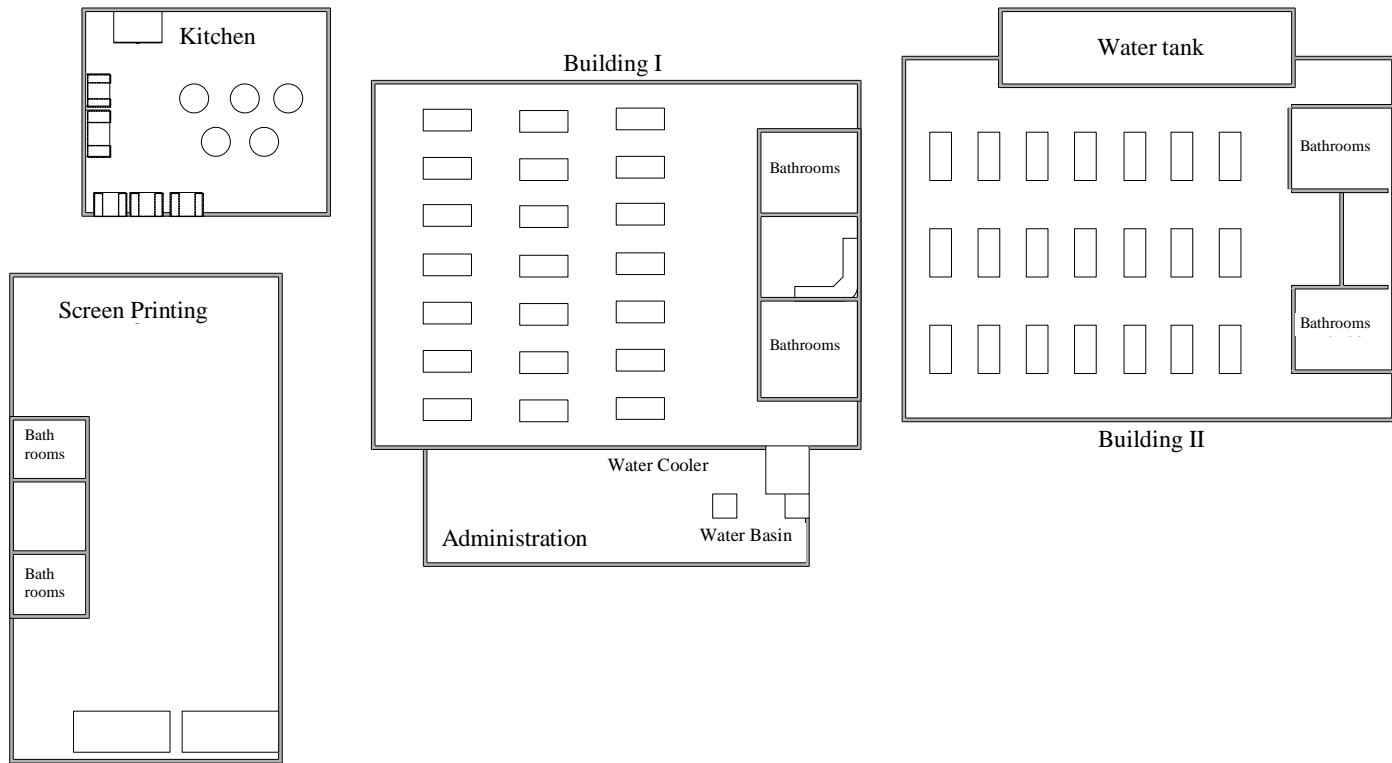
Figure 1. Floor plan for Ocean Sky plant

Ocean Sky occupies 3 plants within the International Free Zone. Building #1 houses the main production lines and the packing department. Building #2 houses the cutting department, two small production lines which produce samples and a warehouse. Building #3 (Screen printing) houses the screen printing and embroidery departments, as shown in figure 1.

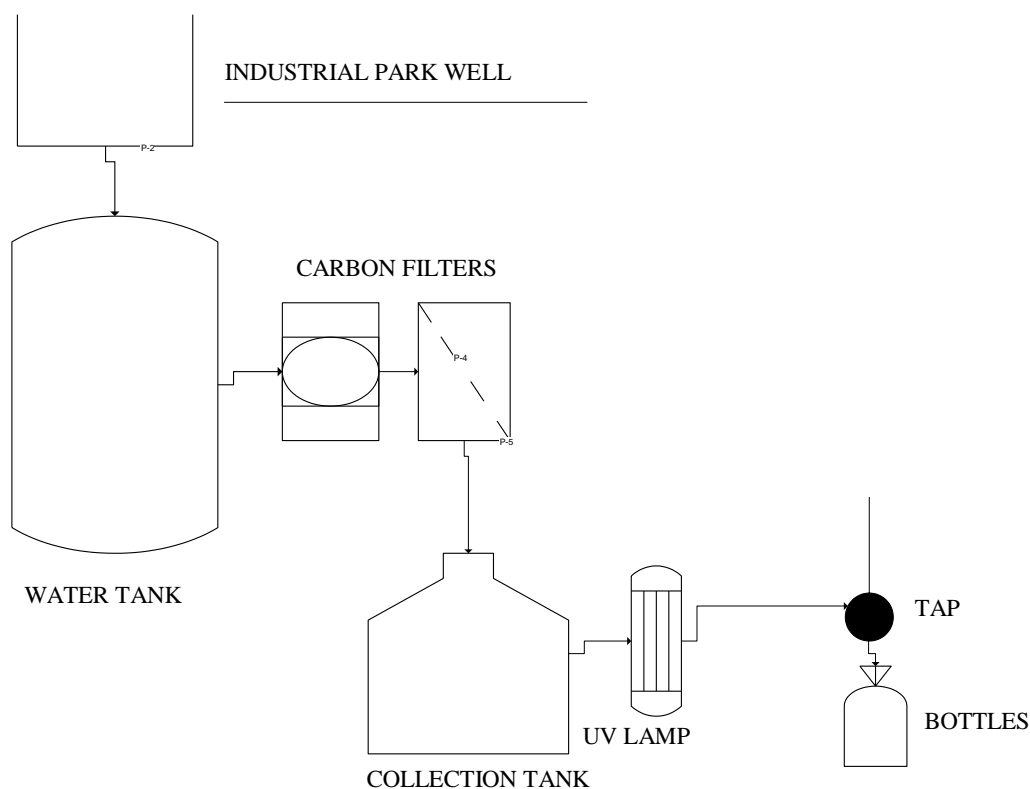
Figure 2. Water Filtration System

- 1- Building 1 y Building 2: Two areas for water filtration are found, according to the system shown in Figure 2.
- 2- In the Screen Printing and Administration areas, drinking water is supplied by commercial bottled water (*Alpina* brand) and distributed through water coolers.
- 3- The Kitchen area is supplied by Water Tank 2, and distributed through sinks. There is a single kitchen, in which meals are prepared. It has a water filter, which supplies the water used for the preparation of meals and a water basin used for washing utensils. The food service concessionaires do not prepare meals on site; they bring prepared meals and lack water systems of their own.

- 3- It is necessary to evaluate the filtration system at each point of input and output of water: before and after the carbon filter, in the water reservoir, before and after the ultraviolet lamp. In order to evaluate if the filtration system is operating adequately.

- 4- Evaluate and normalize the useful life of the filters and UV lamp used in the purification system. Likewise, it is necessary to establish the procedures for cleaning the storage tanks located after the carbon filters.

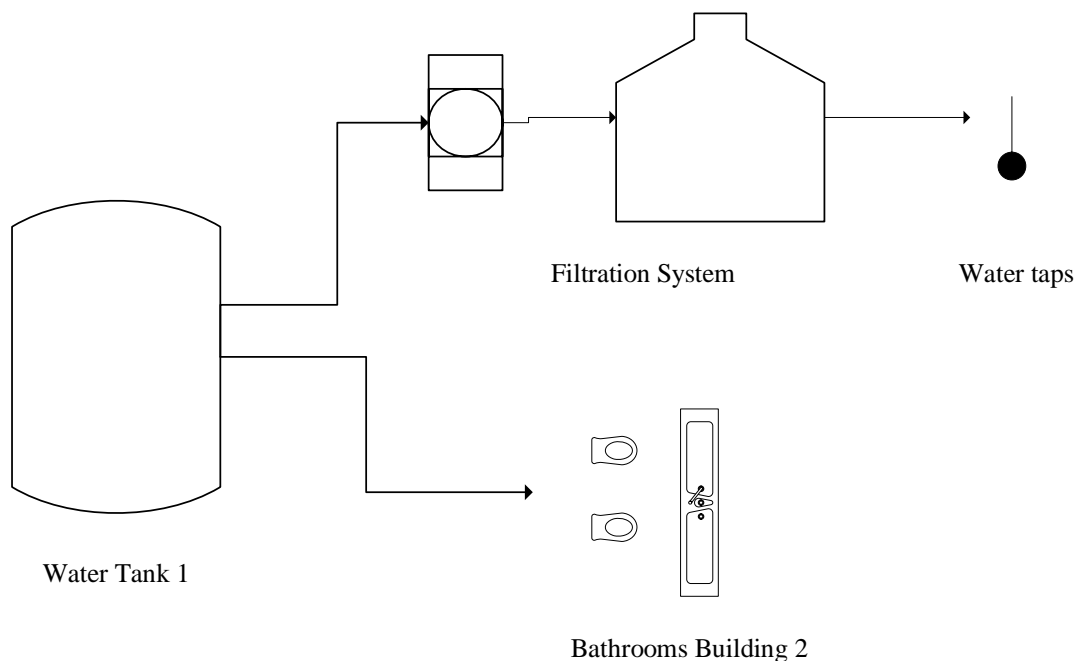
Figure 3. Distribution of water from Water Tank 1

Water Tank 1: located at the rear of building 2. The water in this tank receives a weekly chlorine treatment. This water tank feeds the filtration system for water destined for the consumption of operators. This water tank also supplies the bathrooms in Building 2.

Water Tank 1: Water from this tank is distributed as shown in figure 3, and the results are presented below, which include the temperature of the sample at the time of collection:

ANALYSIS	Total Bacteria Count (CFU /mL)	Total Coliforms (MPN /100mL)	Fecal Coliforms (MPN /100mL)	<i>Escherichia coli</i> (CFU /mL)
Water Tank 1 (29.5°C)	135 x 10 ²	Less than 1.1	Less than 1.1	Less than 1
Filtration System: Building 1 Tap 1 (29.5°C)	365 x 10 ²	Less than 1.1	Less than 1.1	Less than 1
Filtration System: Building 1 Tap 2 (29.0°C)	210 x 10 ²	Less than 1.1	Less than 1.1	Less than 1
Filtration System: Building 2 Tap 1 (28.5°C)	Greater than 300	Less than 1.1	Less than 1.11	Less than 1
Filtration System: Building 2 Tap 2 (28.5°C)	Greater than 300	Less than 1.1	Less than 1.1	Less than 1
NORMA SALVADOREÑA OBLIGATORIA (Salvadorian Mandatory Norm) NSO13.07.01:08	Less than 100	Less than 1.1	Less than 1.1	Less than 1

- 1- Verification and standardization of the procedure for cleaning Water Tank 1 and Water Tank 2: documentation and standardization, in order for it to be performed under the same conditions.

- 2- Normalize the chlorination procedure for the water tank, including the concentration of added chlorine, application method and verification of the effectiveness of the chlorination. Physicochemical controls such as residual chlorine, pH and turbidity can be established.

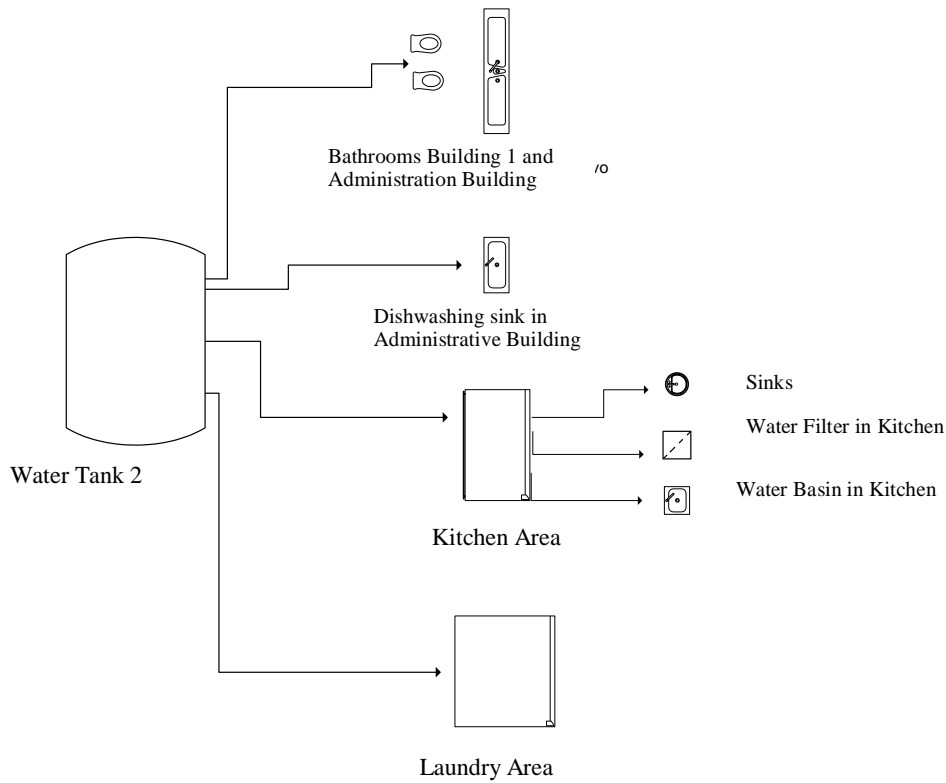
Figure 4. Distribution of water from Water Tank 2

Water Tank 2: located in the Kitchen-Cafeteria area. The water collected here does not receive treatment, because it is used for laundry and the bathrooms in Building 1 and the Administration Building. The Kitchen area is also supplied from this water tank.

Water in this tank is distributed as shown in figure 4, and the results are presented below:

ANALYSIS	Total Bacterial Count (CFU /mL)	Total Coliforms (MPN /100mL)	Fecal Coliforms (MPN /100mL)	<i>Escherichia coli</i> (CFU /mL)
Men's Bathroom Building 1 (30.0°C)	558 x 10 ²	20	20	Less than 1
Women's Bathroom Building 1 (29.0°C)	Greater than 300	20	20	Less than 1
Dishwashing sink Administration Building (29.0°C)	Less than 100	Less than 1.1	Less than 1.1	Less than 1
Kitchen area: sinks (31.0°C)	Greater than 300	20	Less than 1.1	Less than 1
Kitchen area: water filter (31.0°C)	154 x 10 ²	40	20	Less than 1
Kitchen area: water basin (32.5°C)	Greater than 300	300 x 10 ²	Less than 1.1	Less than 1
NORMA SALVADOREÑA OBLIGATORIA (Salvadorian Mandatory Norm) NSO13.07.01:08	Less than 100	Less than 1.1	Less than 1.1	Less than 1
